Summary

Customer
New Homeowner

123 Main Street

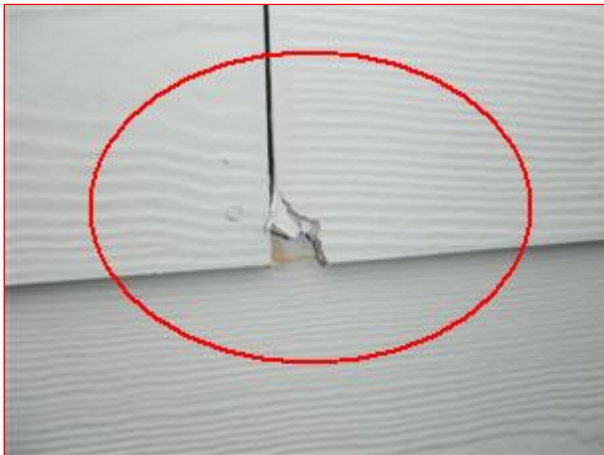
Item 1 - Picture 1

- 1. (1) The Cement board siding at the exterior right side has broken corners at butt joints where nails have been installed too close to corners. This condition prevents siding boards from being properly secured to the structure and could allow water to enter the wall cavities and promote wood decay. Have a qualified technician familiar with proper installation and repair procedures for cement fiberboard siding properly repair all damaged corners at butt joints per manufacturers specifications.

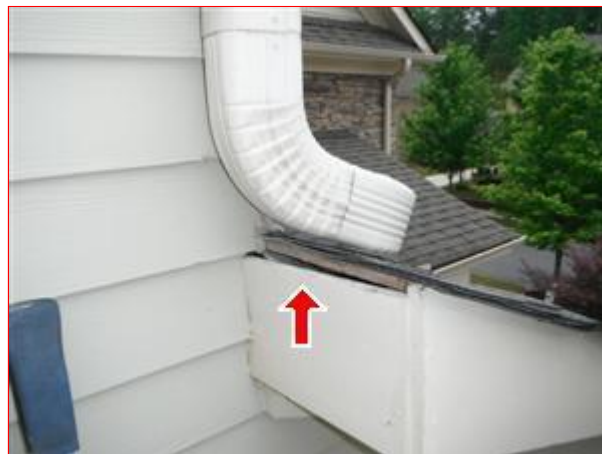
Item 2 - Picture 1

- 2. At left end of front porch, shingles do not properly extend over the edge of the top section of the roof extension. There is a large gap that is a point of moisture entry. There were no indications of water damage at time of inspection, however, continued exposure to moisture could cause problems in the future. Have qualified technician properly add additional shingles and/or flashing at this location to prevent water accumulation in the roof structure.

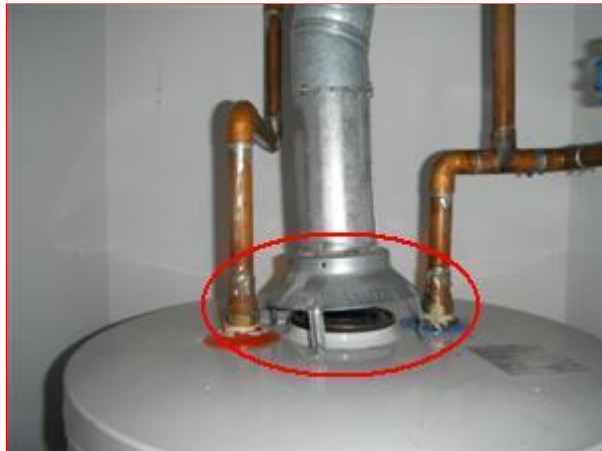
Item 3 - Picture 1

3. The vent collar for the water heater vent is not properly attached to the top of the water heater. This allows combustion products into the surrounding area if the vent collar moves out of position. This is a safety hazard. A qualified technician should repair or replace the vent.

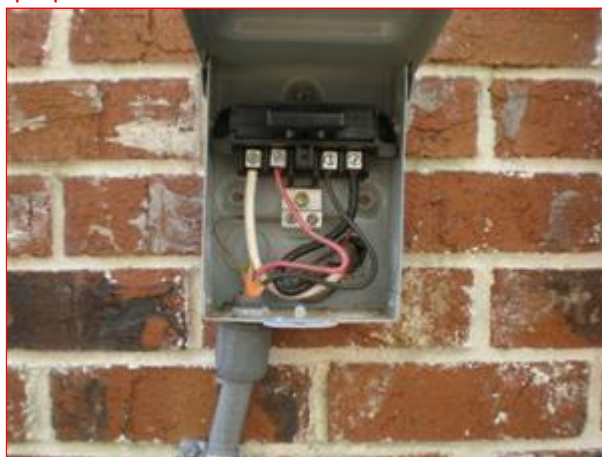
Item 4 - Picture 1

4. The internal cover is missing at one of the exterior condenser electrical disconnect boxes. This is exposing live electrical components and is a safety hazard. Have a licensed electrician install a proper internal cover.

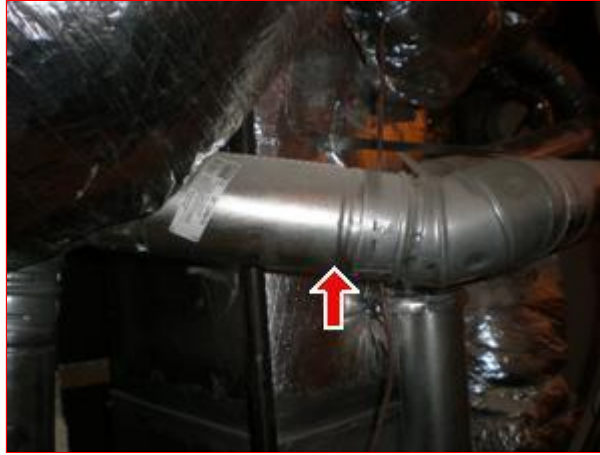
Item 6 - Picture 1

6. The vent pipe for the upper level gas furnace does not have proper continuous uphill slope and fails to rise 1/4 inch per foot. This prevents proper ventilation of the furnace exhaust. I recommend a qualified licensed heat contractor inspect further and repair as needed.

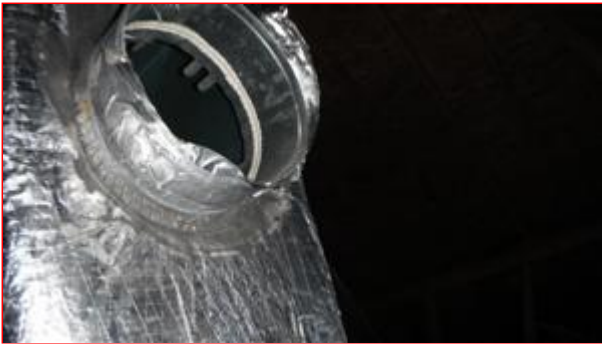
Item 7 - Picture 1

7. A duct pipe is disconnected at an elbow joint in the ceiling at the center front in the basement. Energy loss is occurring. A qualified HVAC person should inspect further and repair or replace as needed.

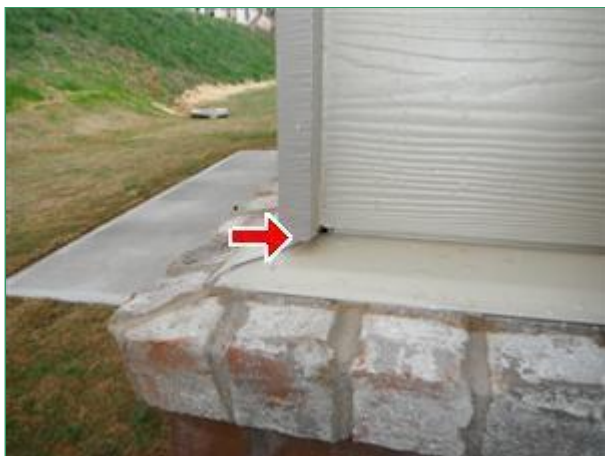
Item 8 - Picture 1

8. (2) There are open joints at several areas of the exterior. Open joints can allow water entry into the wall assembly. Areas include, but are not limited to:
- corner joint of flashing at brick ledge at chimney chase
 - gas pipe penetration at rear chimney chase
 - intersection of brick ledge flashing and windows
 - intersection of brick ledge flashing and patio door
 - perimeter of window frame at center front bedroom
 - intersection of siding and vertical corner trim left front
 - intersection of brick ledge flashing and vertical corner trim left front corner
 - light fixture left side of main entrance

Check ALL exterior wall surfaces for open joints and seal any open joint with good quality exterior caulk and paint as necessary.

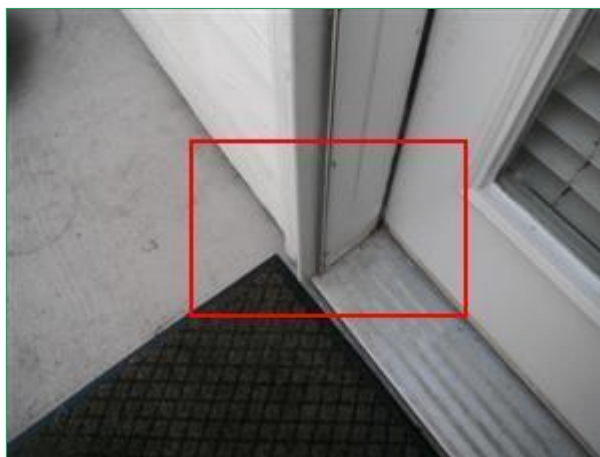
Item 9 - Picture 1

9. The rear patio door jamb is deteriorated or damaged at the threshold, but has not yet affected the performance of the door. Further deterioration can occur if not corrected. The damaged elements of the jamb should be repaired to restore proper operation. A qualified technician should perform the work.
